## Appendix B - Condition Report Photos

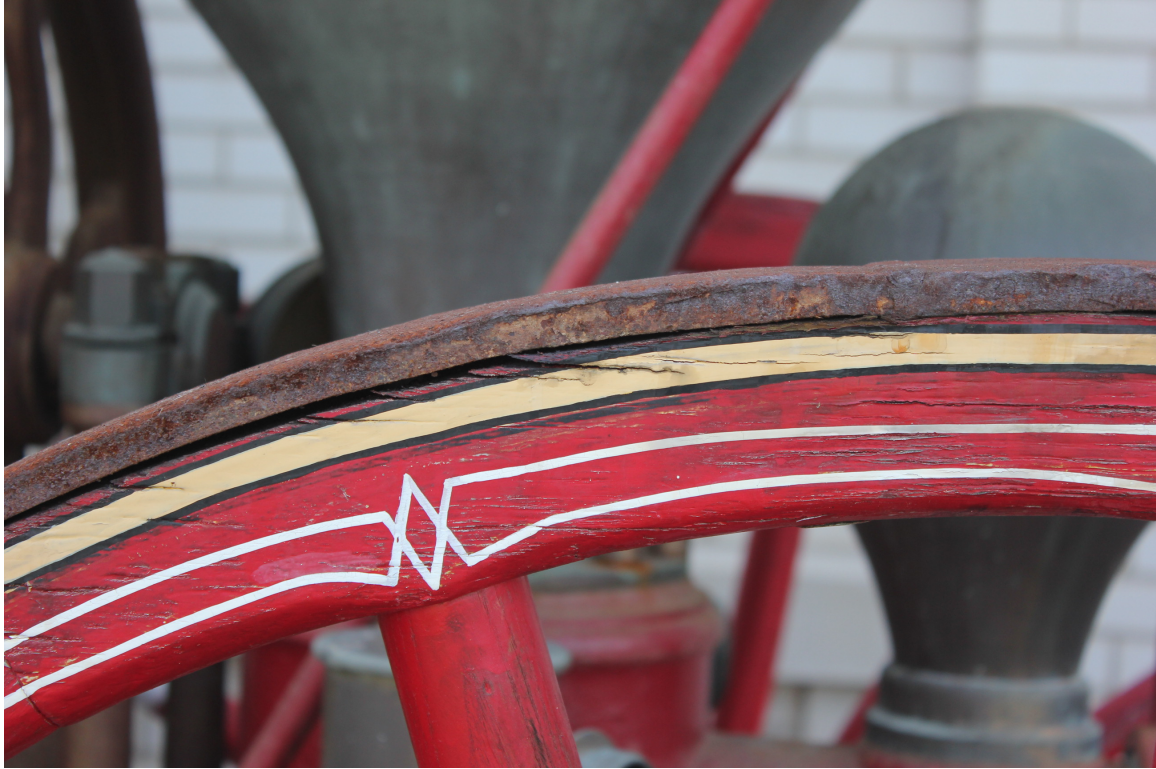
Figure 7 - IMG\_3867.jpg showing cracking of wood.

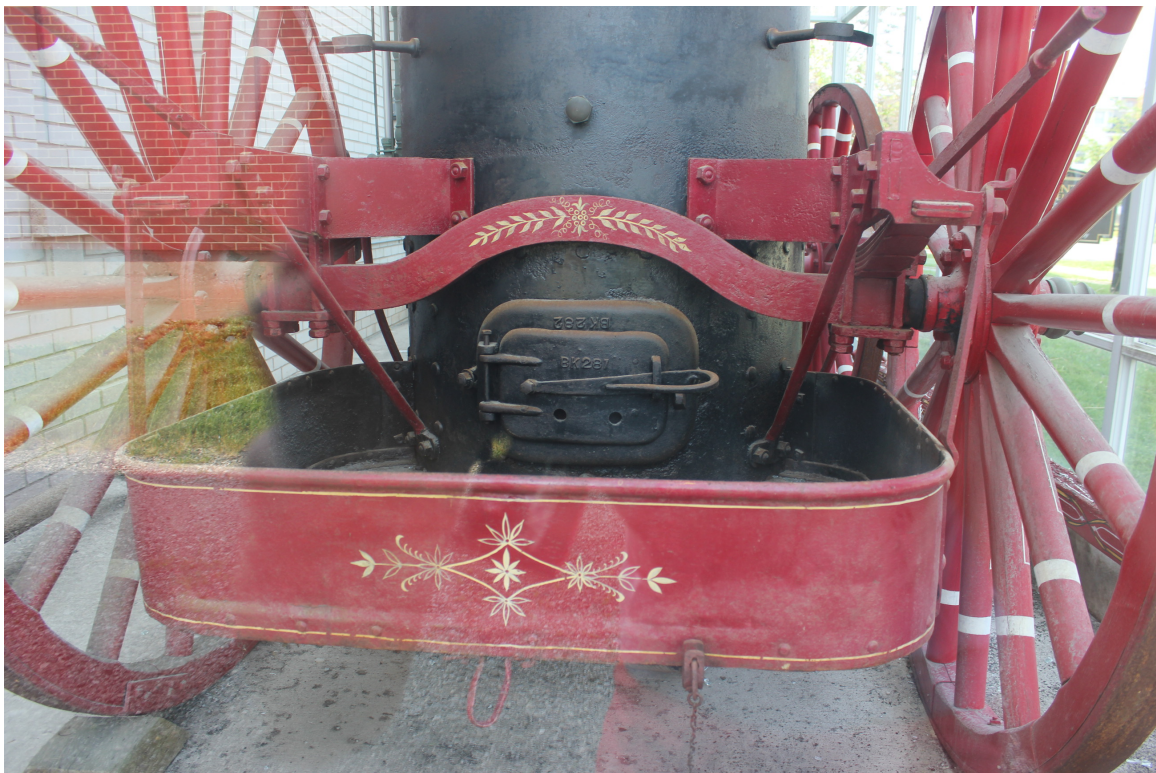
Figure 10 - IMG\_3869.jpg NB: Part numbers on boiler.

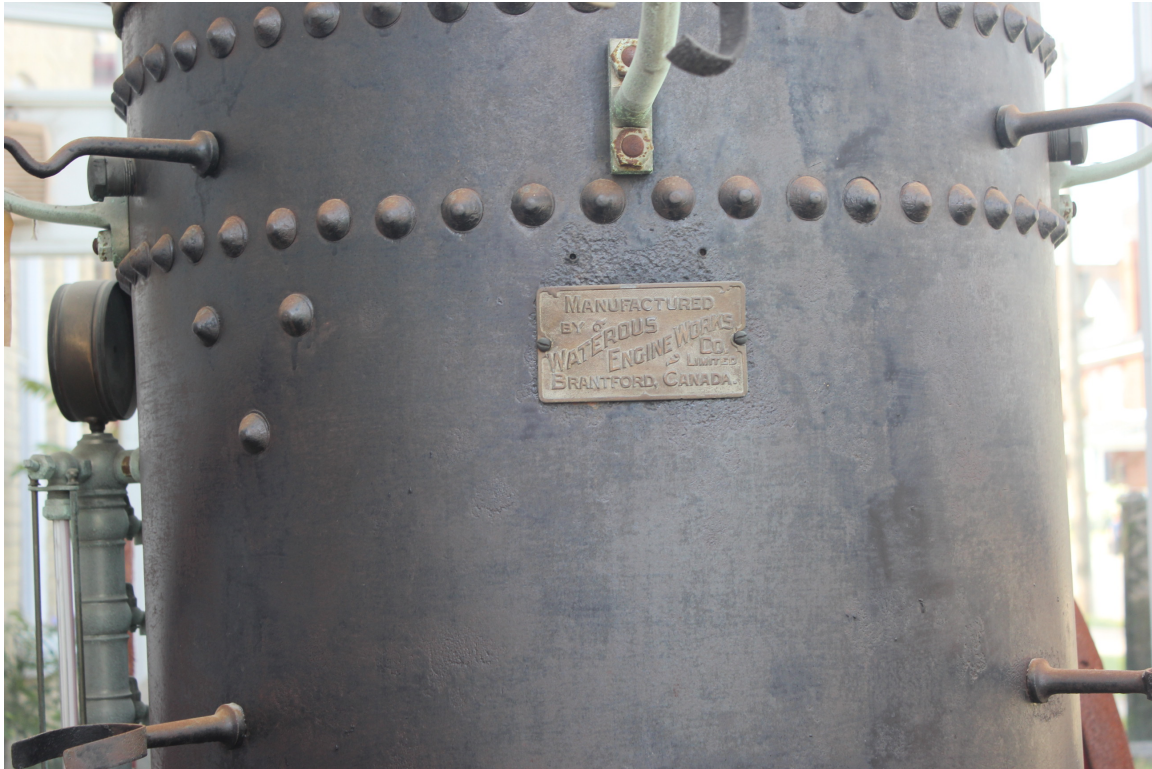
Figure 11 - IMG\_3870.jpg NB: Waterous Logo Nameplate

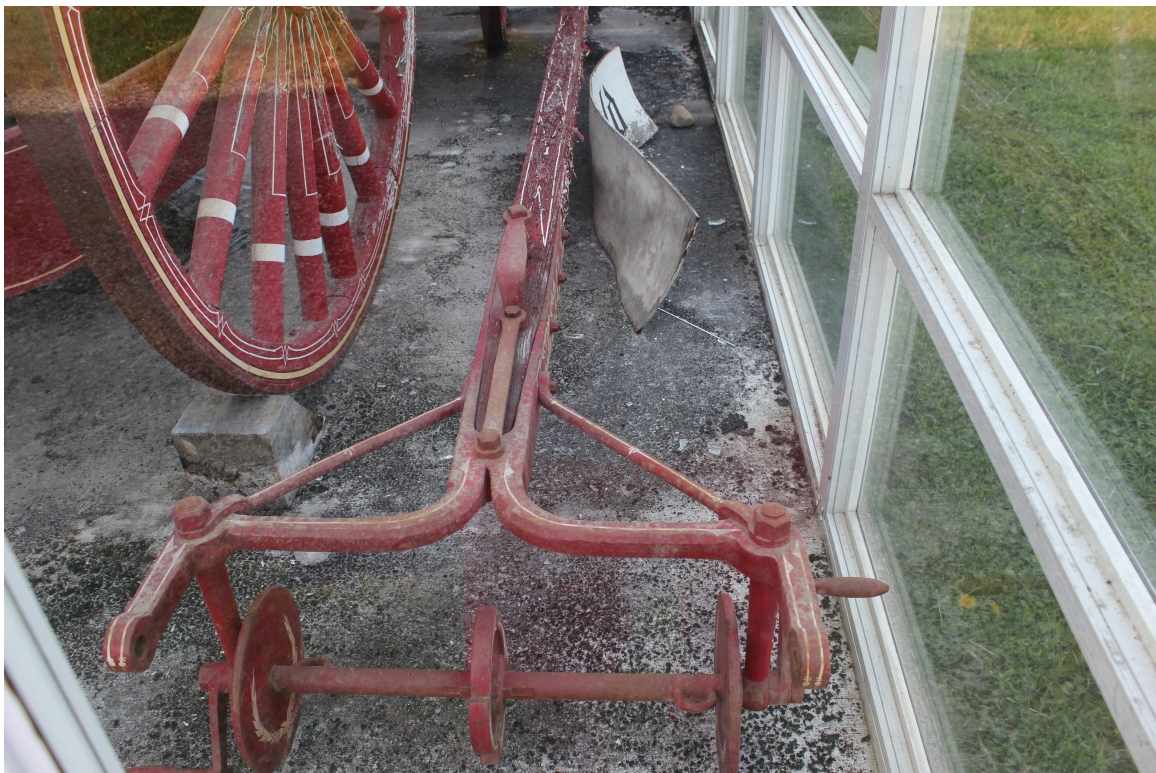
Figure 14 - IMG\_3873 NB: Rock next to sign at the top of the photo was thrown at the glass enclosure in June 2015. No damage appears to have occurred to the artifacts.
