Organic Example

Condition & Treatment Report

Accession #: X 2013.317.01

Object Name: Bible

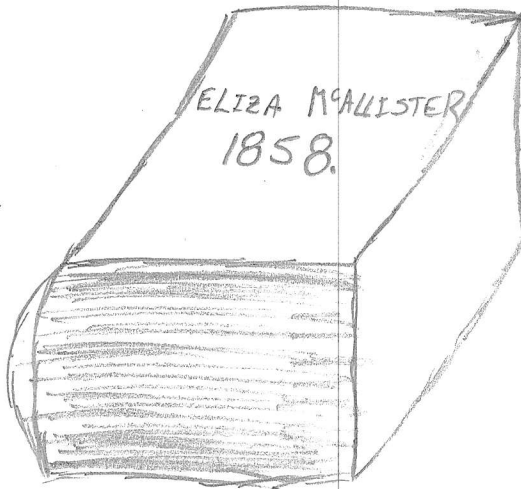
Schematic Diagram(s):

Condition/Defects: Edges and corners are well worn and gold detailing has flaked off. some pages are stained and cover exhibits water damage.

<input checked="" type="checkbox"/>	Abrasion	cover and edges
<input type="checkbox"/>	Accretion	
<input type="checkbox"/>	Additions	
<input type="checkbox"/>	Alternations	
<input type="checkbox"/>	Biological Damage	
<input type="checkbox"/>	active	
<input checked="" type="checkbox"/>	mold/mildew	possible mold on some pages.
<input type="checkbox"/>	pests	
<input type="checkbox"/>	Breakage	
<input type="checkbox"/>	Burns	
<input type="checkbox"/>	Chips/Dents	
<input type="checkbox"/>	Cockling	
<input type="checkbox"/>	Corrosion	
<input type="checkbox"/>	Cracks	
<input checked="" type="checkbox"/>	Discolouration	of cover and paper
<input type="checkbox"/>	Distortion	
<input type="checkbox"/>	Embrittlement	
<input checked="" type="checkbox"/>	Fading/bleaching	of colour of cover
<input checked="" type="checkbox"/>	Flaking	of gold detailing
<input type="checkbox"/>	Coils	
<input type="checkbox"/>	Inherent Vice	
<input type="checkbox"/>	Loose Parts

<input type="checkbox"/>	Missing elements	
<input type="checkbox"/>	Residues	
<input type="checkbox"/>	Scratches	
<input checked="" type="checkbox"/>	Soil	
<input checked="" type="checkbox"/>	surface	some pages appear to have been
<input type="checkbox"/>	dust	spilt on.
<input type="checkbox"/>	ingrained dirt	
<input type="checkbox"/>	grime	
<input type="checkbox"/>	fingerprints	
<input type="checkbox"/>	Splitting	
<input type="checkbox"/>	Stains	
<input type="checkbox"/>	Tears/rips	
<input type="checkbox"/>	Warping	
<input type="checkbox"/>	Weakness	
<input checked="" type="checkbox"/>	Wear	strong wear on cover
<input checked="" type="checkbox"/>	Other	Disassociation.

Book was bound then wrapped,
New treatment will wrap Bible
and then bind it to stabilize

Date	Treatment	Hours
20/05/2016	Wrapped in Tissue, then banded	0.5
TOTAL		0.5

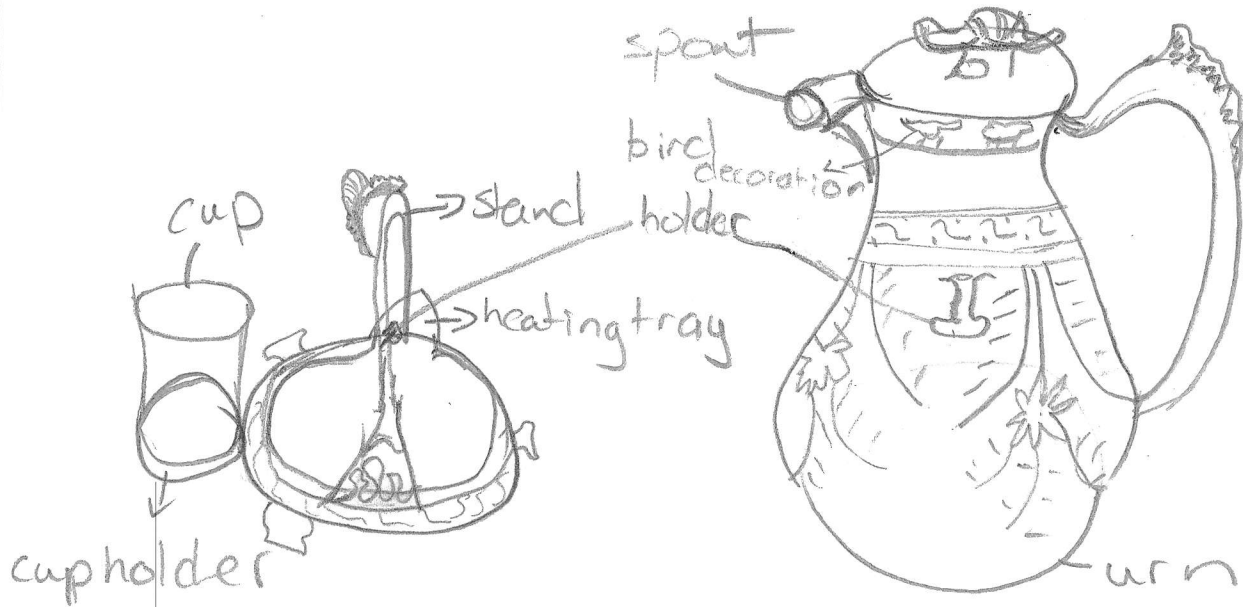
Schematic Diagram(s):

Condition/Defects: Tarnishing

- Abrasion
- Accretion
- Additions
- Alternations
- Biological Damage
 - active
 - mold/mildew
 - pests
- Breakage
- Burns
- Chips/Dents
- Cockling
- Corrosion *there appear to be corrosion on the ornate*
- Cracks *detailing of the stand with a white substance*
- Discolouration
- Distortion
- Embrittlement *→ Tarnish of silver*
- Fading/bleaching
- Flaking
- Foles
- Inherent Vice *→ silver tarnishes under high humidity + air pollution*
- Loose Parts
- Missing elements
- Residues
- Scratches *interior of urn shows scratches + marking due to contents of the vessel.*
- Soil
 - surface
 - dust
 - ingrained dirt
 - grime
 - fingerprints
- Splitting
- Stains
- Tears/rips
- Warping
- Weakness
- Wear
- Other

Any deterioration in the artifact is a result from current storage conditions

Exhibit and Storage Recommendations: Ensure environment for storage + exhibits has lower RH values to diminish further tarnishing.

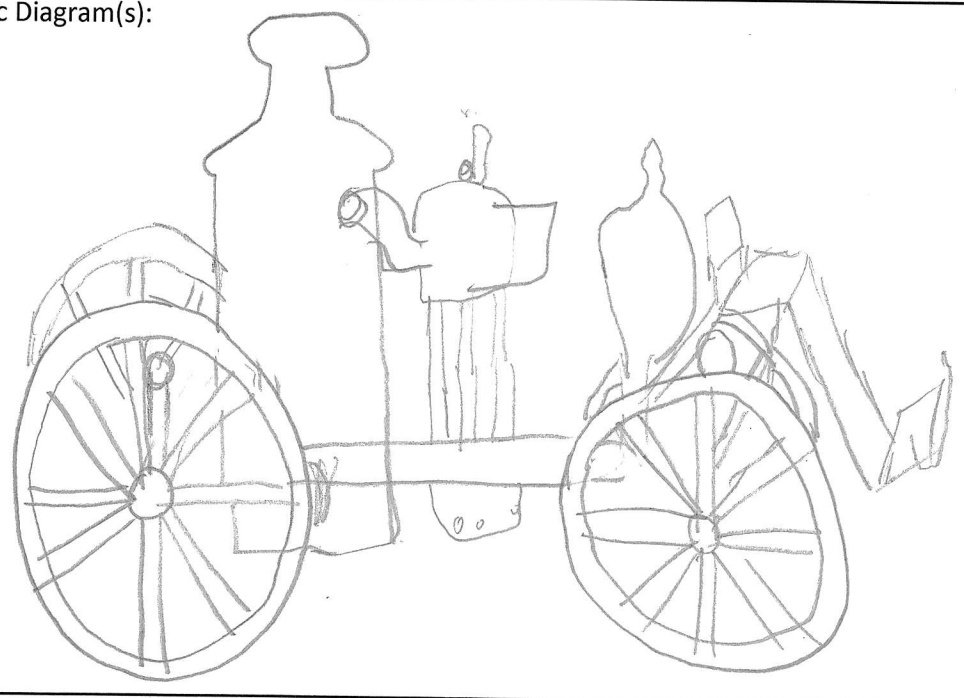
Schematic Diagram(s):

Current Storage: Glass enclosure outside museum. During recent down pour, noticed water leaking through enclosure onto artifact.

Condition/Defects: wooden wheels show cracking of wood from the elements and paint is flaking

<input type="checkbox"/>	Abrasion
<input type="checkbox"/>	Accretion
<input checked="" type="checkbox"/>	Additions new wheel easily identified as back left wheel
<input type="checkbox"/>	Alternations
<input type="checkbox"/>	Biological Damage
<input checked="" type="checkbox"/>	active
	mold/mildew resting on pad covered with black mold
	pests
<input type="checkbox"/>	Breakage
<input type="checkbox"/>	Burns
<input type="checkbox"/>	Chips/Dents
<input type="checkbox"/>	Cockling
<input type="checkbox"/>	Corrosion
<input checked="" type="checkbox"/>	Cracks wooden cracking on wheels
<input type="checkbox"/>	Discolouration
<input type="checkbox"/>	Distortion
<input type="checkbox"/>	Embrittlement
<input type="checkbox"/>	Fading/bleaching
<input checked="" type="checkbox"/>	Flaking of paint detailing on wheels.
<input type="checkbox"/>	Coles
<input type="checkbox"/>	Inherent Vice
<input type="checkbox"/>	Loose Parts

Comments: Storage environment not suitable for conservation of 1892 Fire Pumper.

- Treatment Not Needed
- Stabilization/treatment needed *remove from enclosure and place in climate controlled environment*
- For transportation *remove wheels to transport separately*
- For exhibition *remedial conservation to touch up detailing*
- Need improved storage conditions *removed from glass enclosure*
- Needs further inspection *required PPE to do close up inspection*
- Other *No resources exist within the organization to pay for these large costs of time + money. No treatment was therefore done.*
