Description of Property – Brant Museum & Archives, 57 Charlotte Street

Maintenance Inspection Report

Risk Assessment

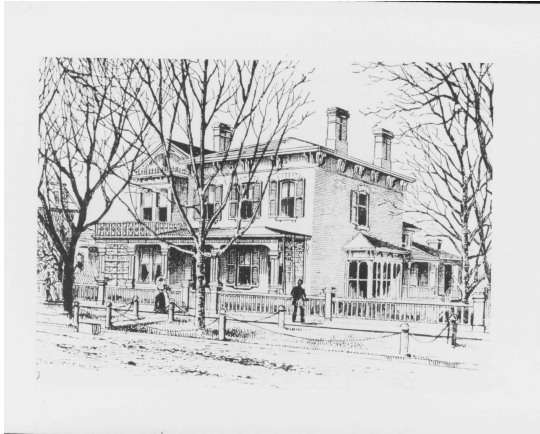
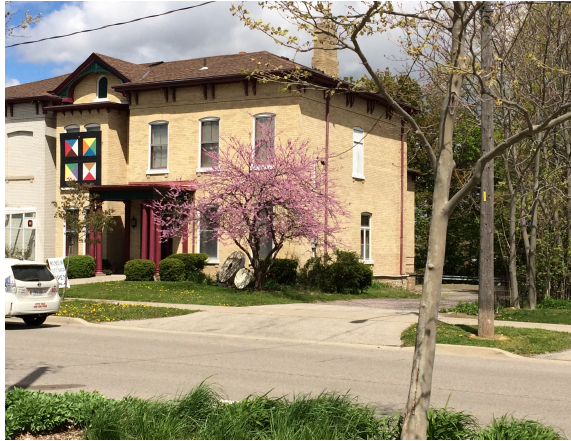
The original dwelling is a two-storey Italianate design located on the east side of Charlotte Street and is described as Part Block P West of the Wilkes Tract and Part Block C in the Wilkes Tract plus Right of Way.

The original structure is representative of an Italianate style Victorian-era residential dwelling with three two-flue chimney stacks. The plan has a large, square main block with a slight recessed rectangular side block with a slightly recessed rectangular side block with a gabled roof over a two-storey square bay window. The stylistic brackets rest on a single corbelled stretcher course. The side light and transom over the entryway are original fixtures to the façade with the original gas lamp fixture that has been modified with electric lighting. The addition to the property mimics the design elements of the Victorian dwelling with the continuation of bracketing and blind windows with voussoirs.
